UTAH STATE CAPITOL ARCHITECTURE: EXTERIOR SURVEY REPORT

ELEVATION LOCATION: EAST ELEVATION

Survey Date: 4/25/00

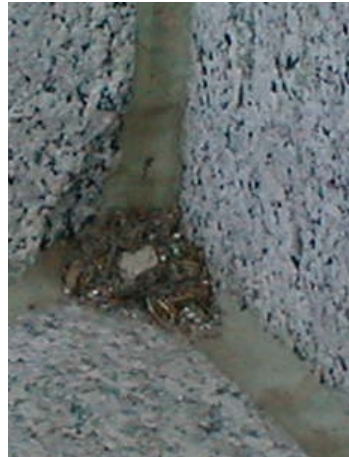
Grid: B/S6.6

Description: Foundation stone

Location: front steps

Condition: BR, INT

Broken element, intrusive element

Comments: metal anchors

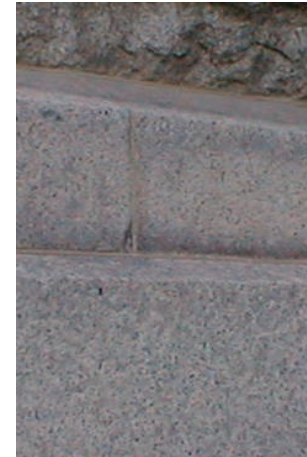
Grid: B/S 90; B/N 60

Description: Foundation stone

Condition: J

Mortar joint with missing or loose mortar

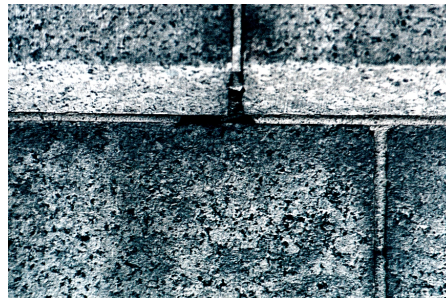
Grid: C/S 90

Description: Foundation stone

Condition: CR

Cracked element

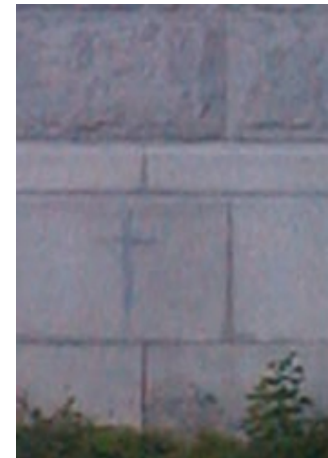
Grid: B/S70, S 62

Description: Foundation stone

Location: south side

Condition: CR, J

Cracked element and mortar joint damage

Comments: 30" crack and 3" joint

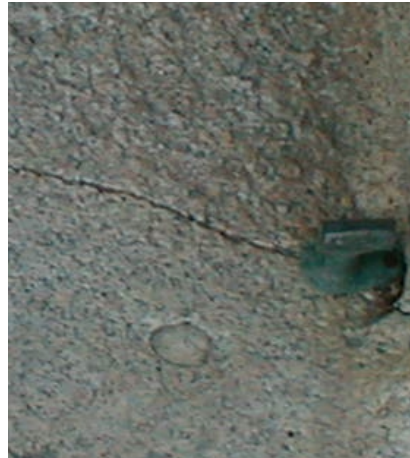
Code: EX-001**Description: Foundation stone****Location:** center**Grid:****Condition:** CR, J

Cracked element and mortar joint damage

Comments: CR threshold, center door 30" B/L ; J2" B/N-6

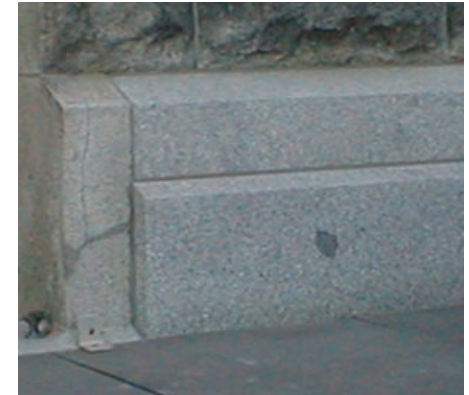
**Code: EX-001****Description: Foundation stone****Location:****Grid:** B/N-19**Condition:** BR, PAT

Broken element, poor quality patching

Comments: broken piece patched back in.

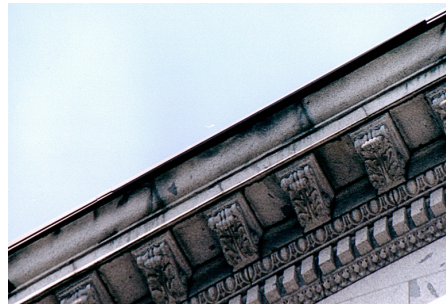
**Code: EX-003****Description: Lower belt course****Location:****Grid:** G/S 54**Condition:** J

Mortar joint with missing or loose mortar

Comments: 6"

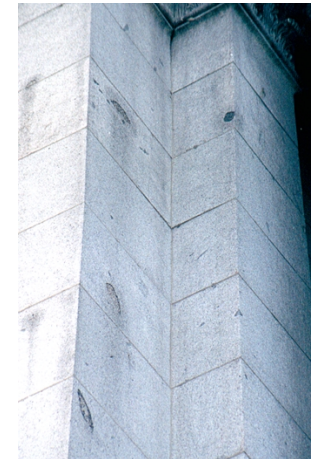
**Code: EX-006****Description: Pilaster shaft****Location:****Grid:** E & D / S 74**Condition:** EX

Exfoliated or spalled surface

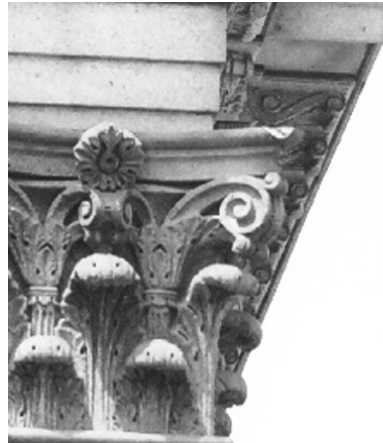
Grid: F/N 102, N 116

Description: Pilaster capital

Condition: BR

Broken, severely cracked or
chipped

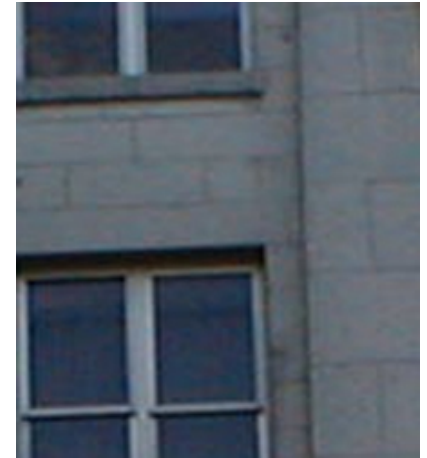
Grid: E/N 116

Description: Wall stone

Condition: CR

Cracked element

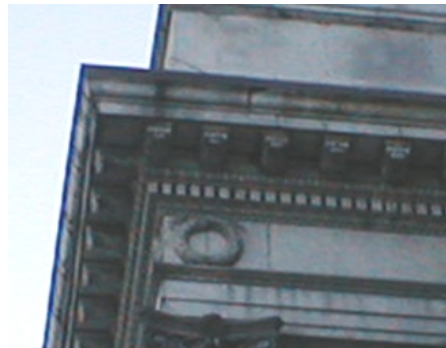
Grid: F/S 90

Description: Entablature lower belt

Condition: CR

Cracked element

Comments: soon to be BR

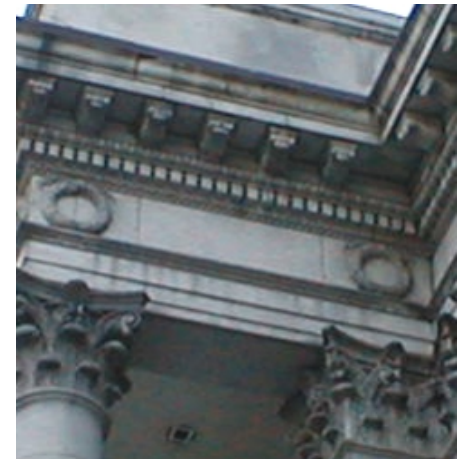
Grid: G/74

Description: Entablature frieze

Condition: C

General Cleaning Needed

Comments: dentil joint dark, wreath dark

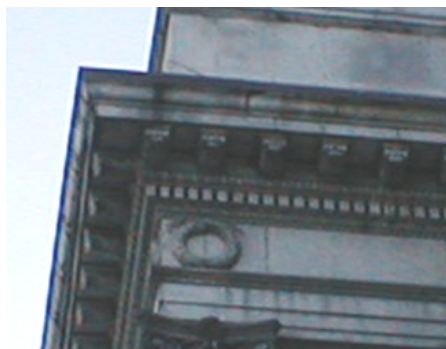
Grid: G/S 95

Description: Entablature cornice

Condition: ST

Significant Staining; may
indicate rusted connector

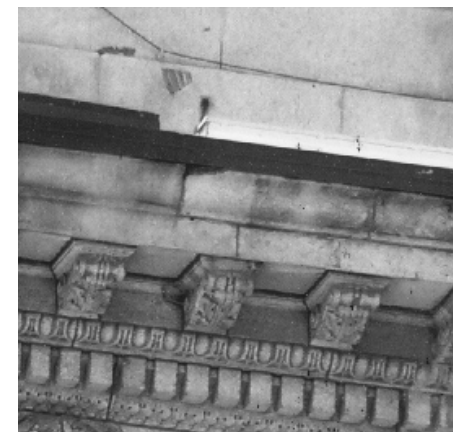
Grid: G/S 70-90

Description: Entablature cornice

Location: at front steps

Condition: BR, ST

Broken element, significant
staining

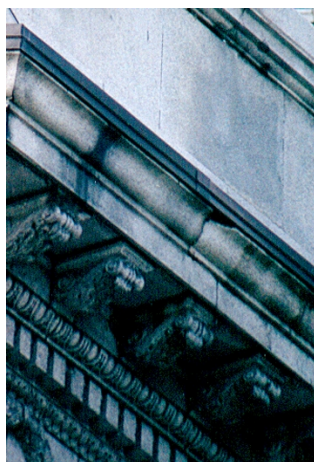
Description: Entablature cornice

Condition: BR, ST

Broken element, significant
staining

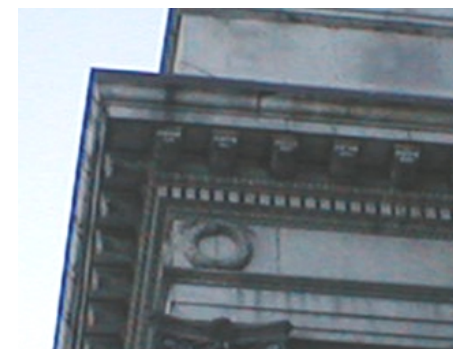
Grid: G/S 90

Description: Entablature cornice

Condition: J, ST

Mortar joint damage and
significant staining

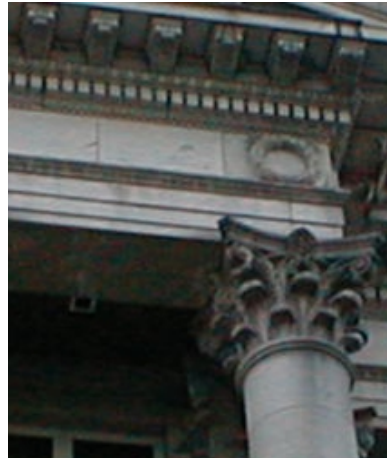
Code: EX-012**Description: Entablature cornice****Location:** center**Grid:** G/H, N/S 46**Condition:** ST, CR

Significant staining and cracking

Comments: ST-3 spots, 2 medallions are whiter (new?) with severe staining behind and beneath.

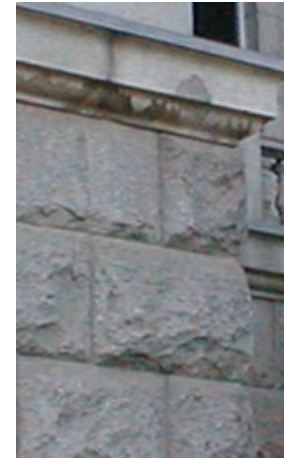
**Code: EX-017****Description: Balustrade baluster****Location:****Grid:** C/S 38**Condition:** PAT, ST, EX

Poor patching, staining, and exfoliation

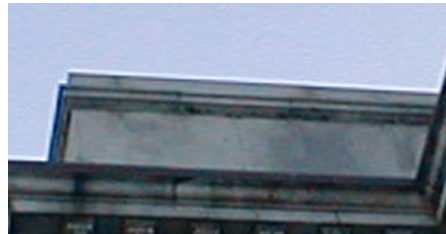
**Code: EX-018****Description: Balustrade railing****Location:****Grid:** H/S 80**Condition:** BR

Broken, severely cracked or chipped

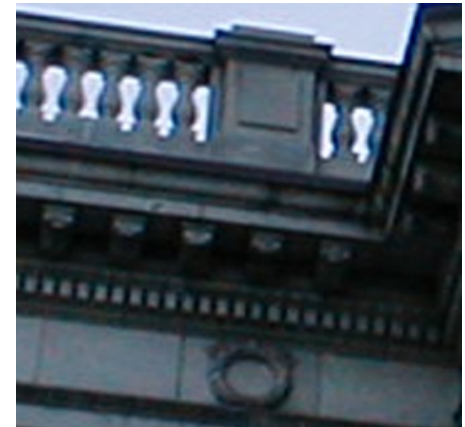
**Code: EX-018****Description: Balustrade railing****Location:****Grid:** H/S 60**Condition:** J, ST

Mortar joint damage and significant staining

Comments: significant staining

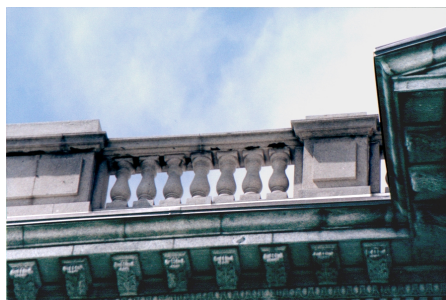
Code: EX-018**Description:** Balustrade railing**Location:** North entrance**Grid:** H/N 95**Condition:** J

Mortar joint with missing or loose mortar

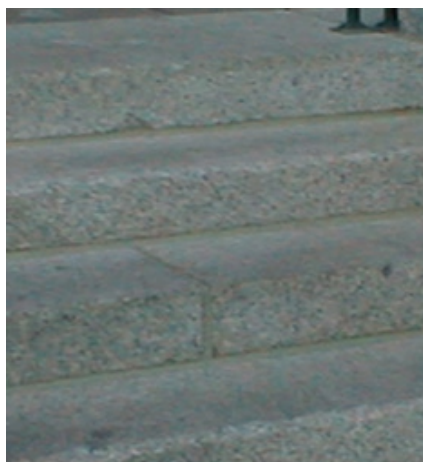
Code: EX-074**Description:** Stairs**Location:** stairs**Grid:** B/N-10**Condition:** BR

Broken, severely cracked or chipped

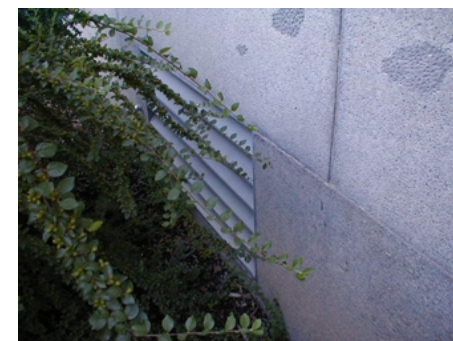
**Code:** EX-093**Description:** Trim**Location:****Grid:** C/S 46, N 46**Condition:** NO

Non-original, incompatible but essential elements

Comments: grey flashing/ protector

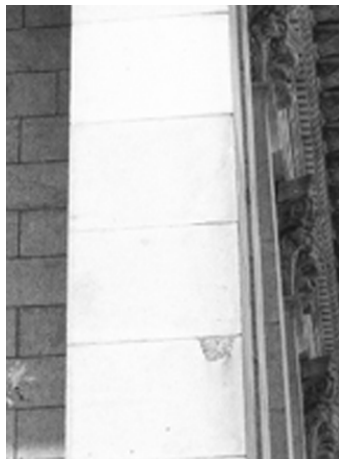
Grid: D/N 75

Description: Trim

Condition: EX, PAT

Exfoliation, poor patching

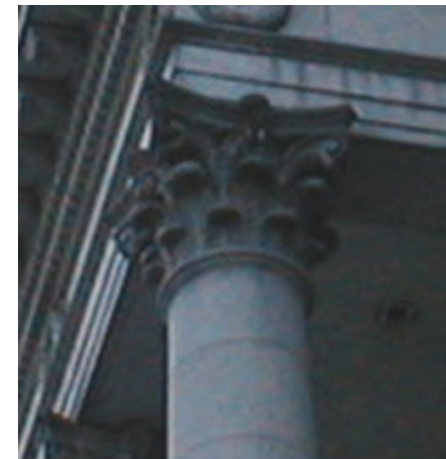
Grid: F/S 90

Description: Trim

Condition: BR

Broken, severely cracked or
chipped
